ASSESSMENTS AND EXPERTISE OF THE PATHOLOGICAL MANIFESTATIONS OF A RESIDENTIAL COMPLEX LOCATED IN THE SQUARE 14 OF JANUARY NEIGHBORHOOD IN THE CITY OF MANAUS

This article aims to analyze the causes of pathological manifestations in a residential complex. This in situ investigation investigated and identified the types of pathologies found in the concrete structure as well as cataloging the main manifestations in specific rooms of the complex's central residence. From this, an appropriate treatment was determined for each room, meeting the specifications of ABNT technical standards for the recovery and maintenance of the structure. The manifestations found were: cracks, cracks, repression, stains, shedding of the paint on the walls and ceiling, leaching, efflorescence, carbonation, corrosion and exposure of the armor. These manifestations appeared in a very short period of the useful life of the structure after the completion of the building, around 7 years, which revealed many errors in architectural design, materials without technological control and with inferior functionality and quality, among others.

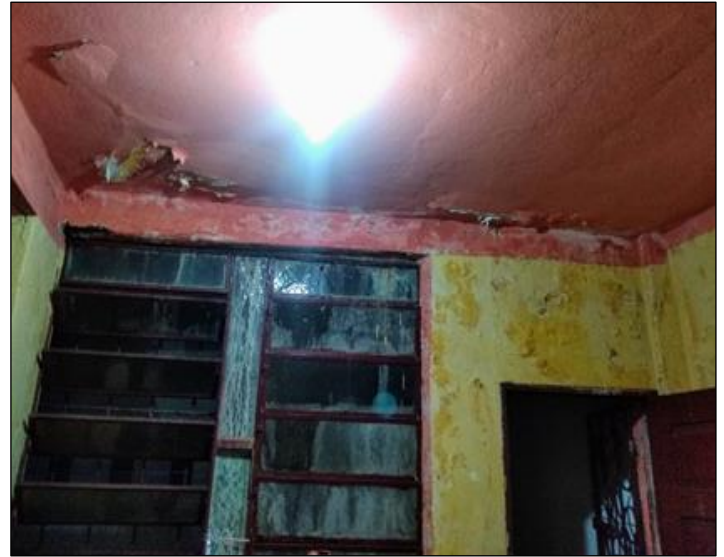
Figure 1, below, shows stains all over the kitchen wall as well as details the detachment of the painting from both the wall and the ceiling (slab). The kitchen is located under the service area of the residence on the first floor where there is no gutter or water drainage pipe as shown in Figure 2, below.

Figure 1: Stains and paint detachment on the kitchen wall of the residence under evaluation.
Source: Authors, (2020).

The waterproofing of these structures is also a viable alternative both in the appearance of new manifestations and in the interruption of the aggravation of the manifestations that are in the place.

d) The waterproofing of the affected areas will stop the growth and the appearance of new pathological manifestations in the structure of the complex;

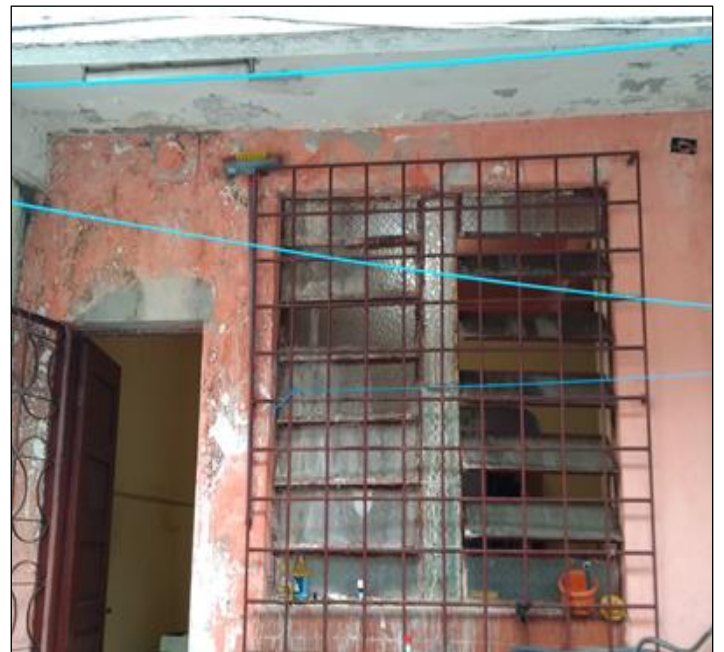
Figure 2: External area of the kitchen wall where the service area of the current residence is located.
Source: Authors, (2020).

Despite the fact that the residence is well ventilated and the side walls diagnosed with pathological manifestations where the afternoon sun is intense, the water that comes from the upper floor would have to be drained with an external pipe that went to the sewers in order to stop the constant flow of water. Water on these walls and thus not seeping into the soil causing a possible expansion in the reinforced concrete structure, even if it is thermal as well as functional.

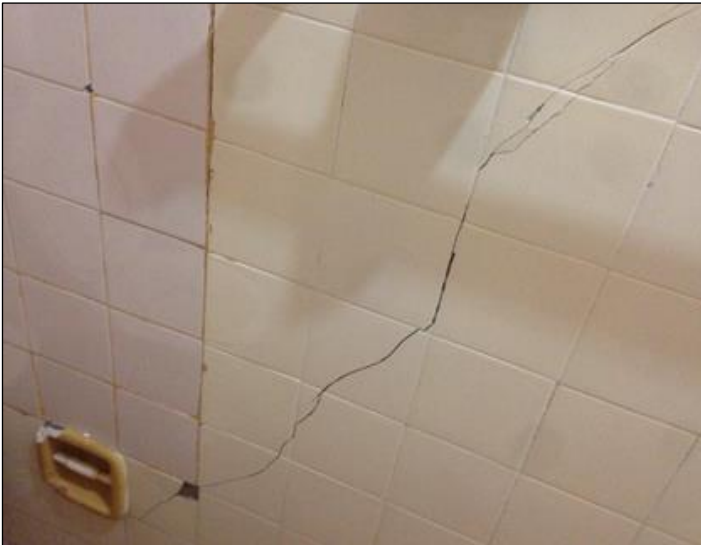
In Figure 3, below, it shows one of the many cracks in the bathroom of the residence caused by repression in the structure.

Figure 3: Crack in the bathroom wall caused by repression of the structure.

c) The cracks and cracks found in the residence under study were caused due to the settlement where the structure sank due to excess weight in the soil where it is notable that the foundations chosen at the time of construction are not suitable for this complex;

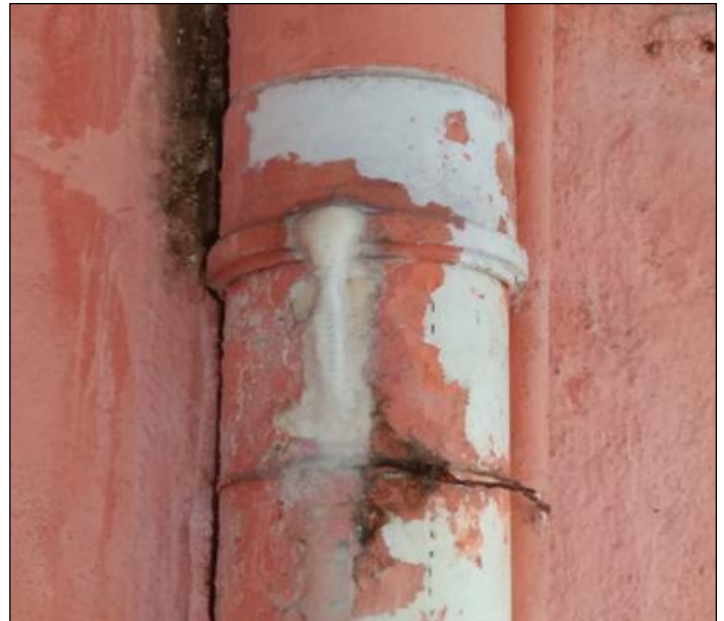
In Figure 4, below, one of the leaching processes is shown, which in this case is the thick white stain forming a foam in the external pipe that comes from the floors above.

Figure 4: Leaching in the external piping of the service area.
Source: Authors, (2020).

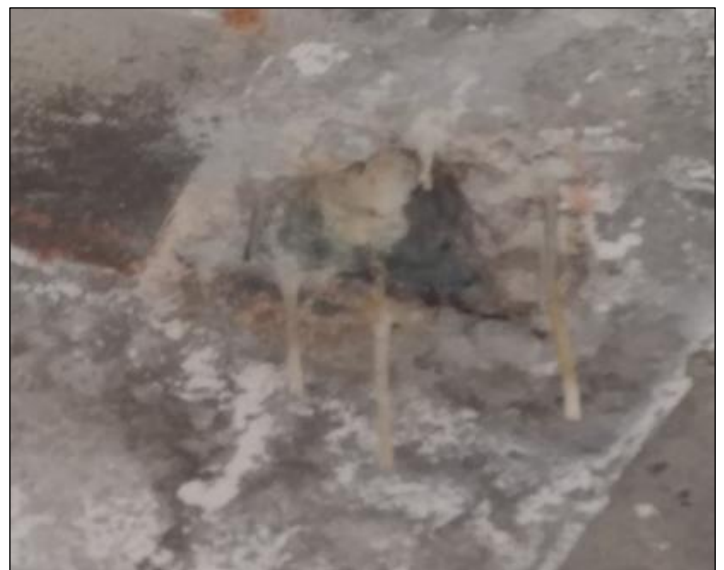
In Figure 5, below, it shows a case of efflorescence in a semi-open hole in the slab in the service area of the house in evidence. It is noted that the pathological manifestation covering the whole orifice with drool and whitish spots is quite aggravated. It is also observed that the drool has an orange tint showing that the metallic structure is exposed.

Figure 5: Efflorescence and leaching in the semi-open hole in the service area slab.
Source: Authors, (2020).

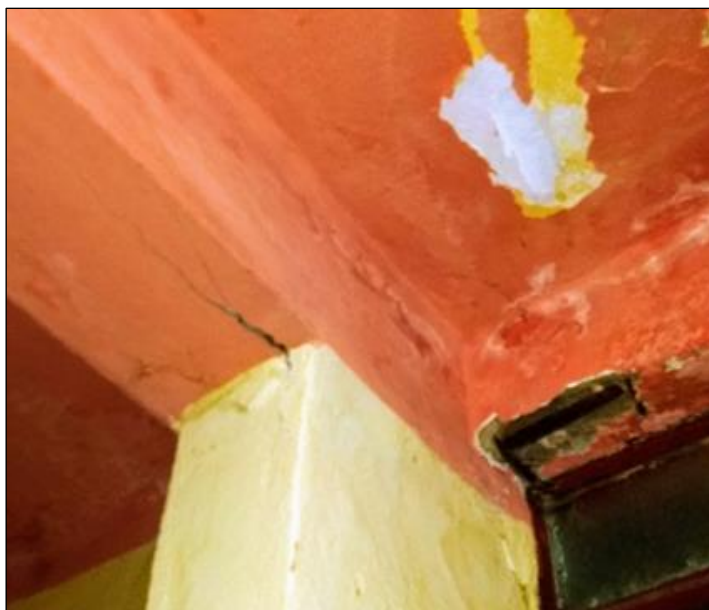
In Figure 6, below, it shows the corrosion process and the detachment of the concrete metal reinforcement caused, possibly by the carbonation effect, where a part of the structure was exposed, being vulnerable to pathological manifestations.

Figure 6: Corrosion caused by the effect of carbonation on the reinforced concrete structure.

e) For the exposed areas of the reinforcement of the reinforced concrete structure, it is suggested that they be treated and covered with the appropriate ABNT specifications.
